Phase 1 Fall of 2010

Main Lodge Perimeter Footing Replacement Begins!

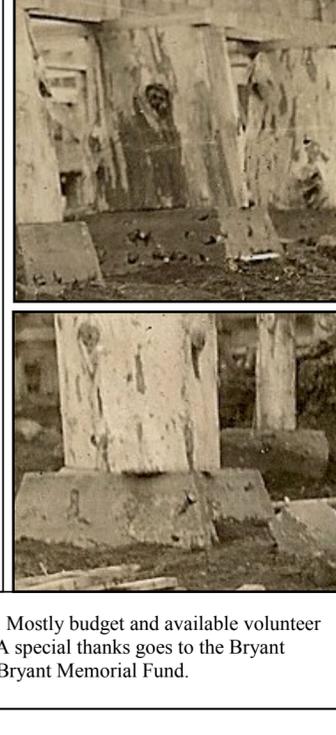
On November 19th 1934, the pictures to the right was taken as a part of the WPA project report folder. You'll notice that the concrete footings have a bunch of spots---rocks---that were used as the core of the footings for the lodge. In fact, all the footings are a combination of grout that locks the rocks together, capped with concrete. The conditions of the old Humboldt Road from Chico to Butte Meadows must have made cement a premium. As typical of these mountain projects, you used what you had, and for 78 years these footings held true.

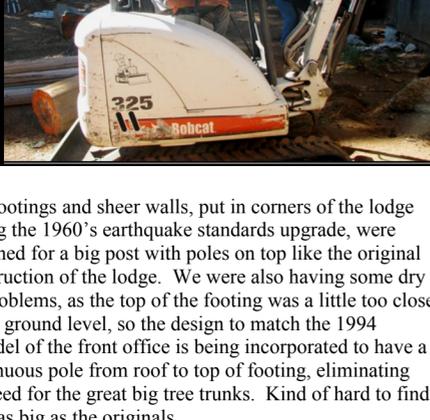
Some people have way too much fun! Matt Adema is having a blast breaking up the old footings at the front of the Lodge. The existing footings were only down 8" to 12" on the west side, and we needed a 24" deep footing.

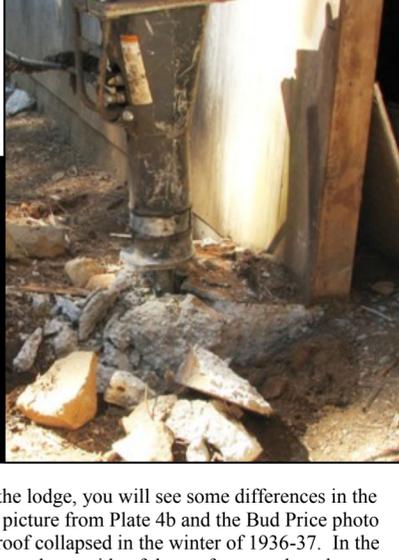
The footings and sheer walls, put in corners of the lodge during the 1960's earthquake standards upgrade, were designed for a big post with poles on top like the original construction of the lodge. We were also having some dry rot problems, as the top of the footing was a little too close to the ground level, so the design to match the 1994 remodel of the front office is being incorporated to have a continuous pole from roof to top of footing, eliminating the need for the great big tree trunks. Kind of hard to find trees as big as the originals.

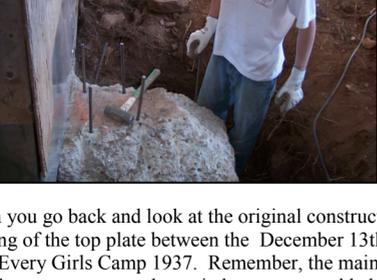
In the photo below, the 1960's earthquake retrofit footings that were installed by Ben and Butch Filer are getting a new bigger and complementary design.

The footings on the east side of the lodge were still deep enough to use the core of the earthquake footing, but some of the old fashioned sweat equity of pounding in the re-bar was earned by Jake Thorup of Troop 2 shown below

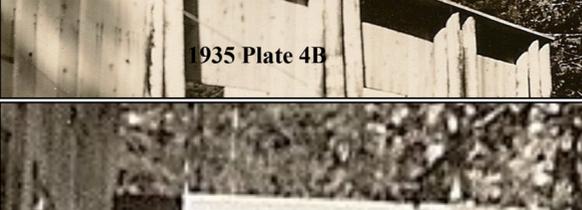
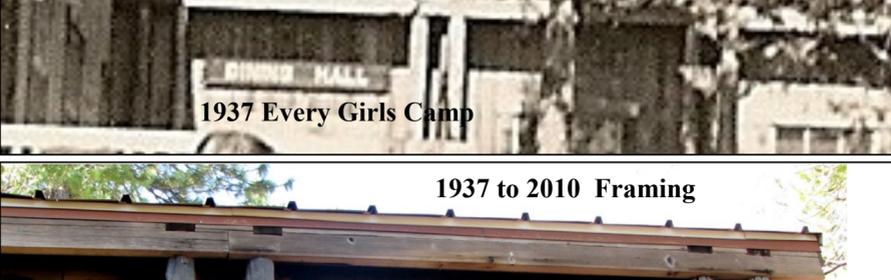
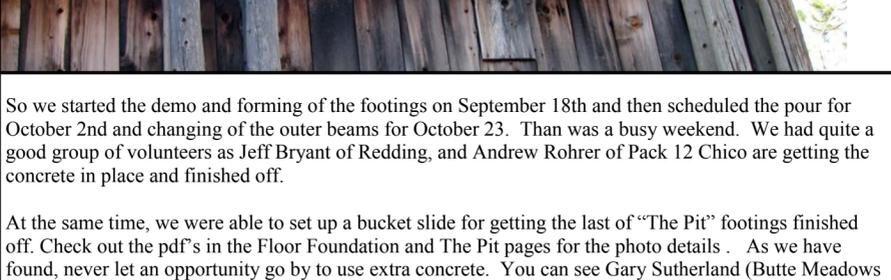
1937 to 2010 Framing

When you go back and look at the original construction of the lodge, you will see some differences in the top plate between the December 13th, 1935 picture and the Bud Price photo from Every Girls Camp 1937. Remember, the main lodge roof collapsed in the winter of 1936-37. In the 2nd photo, you can see the main beams were added not only to the outside of the roof trusses, but also against the wall of the siding.

Unfortunately, the outer existing beams now have dry-rot in various places and will be replaced while the poles are being changed. Too bad we can't find the same dimensional size of the outer beam, but a good old fashioned 4 x 6 will work just fine. Somehow we missed the photos of John and Uriah Bakke, from Precision Construction and Maintenance, and Chico Home Improvement, but without there help and equipment, we could not have been ready for the concrete pour.

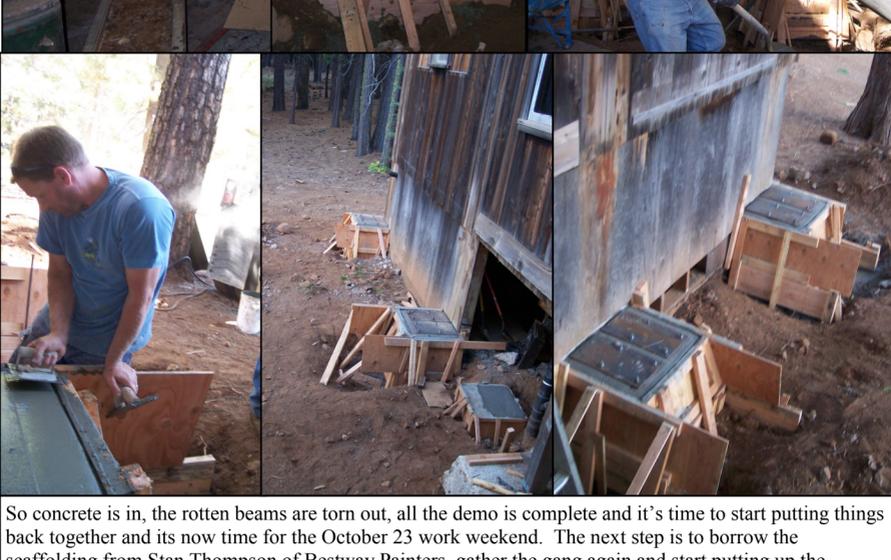
So we started the demo and forming of the footings on September 18th and then scheduled the pour for October 2nd and changing of the outer beams for October 23. Than was a busy weekend. We had quite a good group of volunteers as Jeff Bryant of Redding, and Andrew Rohrer of Pack 12 Chico are getting the concrete in place and finished off.

At the same time, we were able to set up a bucket slide for getting the last of "The Pit" footings finished off. Check out the pdf's in the Floor Foundation and The Pit pages for the photo details. As we have found, never let an opportunity go by to use extra concrete. You can see Gary Sutherland (Butte Meadows Jonesville Community Association) sliding down the buckets and the legs of Joe Matthews filling up the concrete tub.

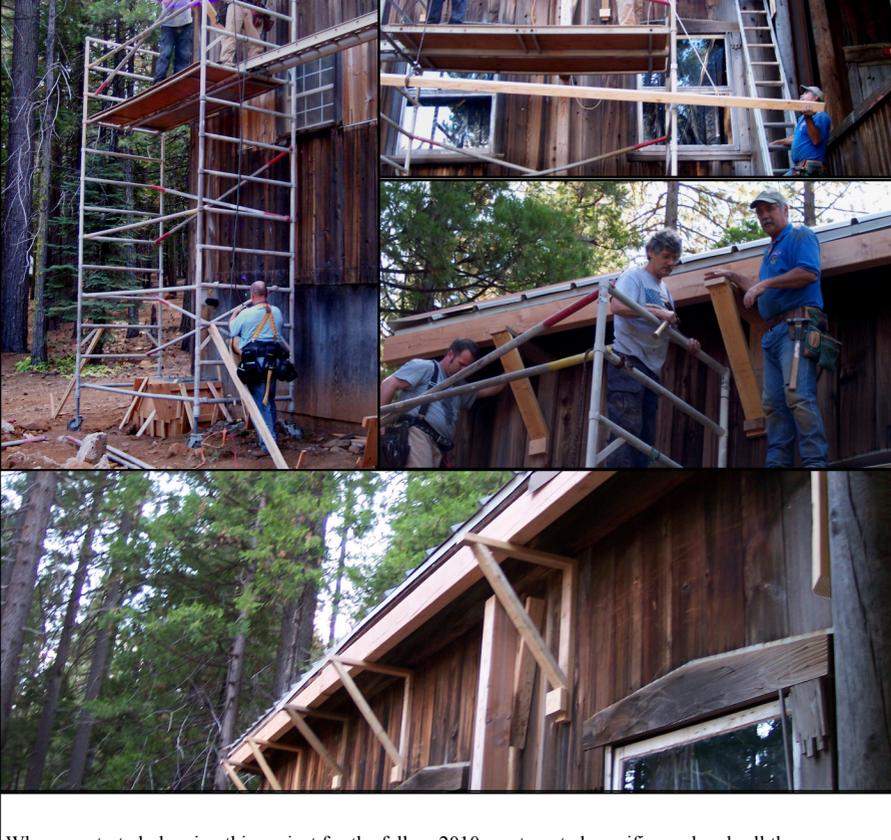
So concrete is in, the rotten beams are torn out, all the demo is complete and it's time to start putting things back together and its now time for the October 23 work weekend. The next step is to borrow the scaffolding from Stan Thompson of Bestway Painters, gather the gang again and start putting up the replacement beams. It's no easy task to get real long heavy beams up about 20 feet, but if you ask Travis Vodden, Jim Thorup, Jeff Bryant and Jim Anderson, they would tell you its no big deal. Thank Heaven for scaffolding.

By the end of the day, both sides of the front of the lodge have the new beams and are ready for the installation of the poles.

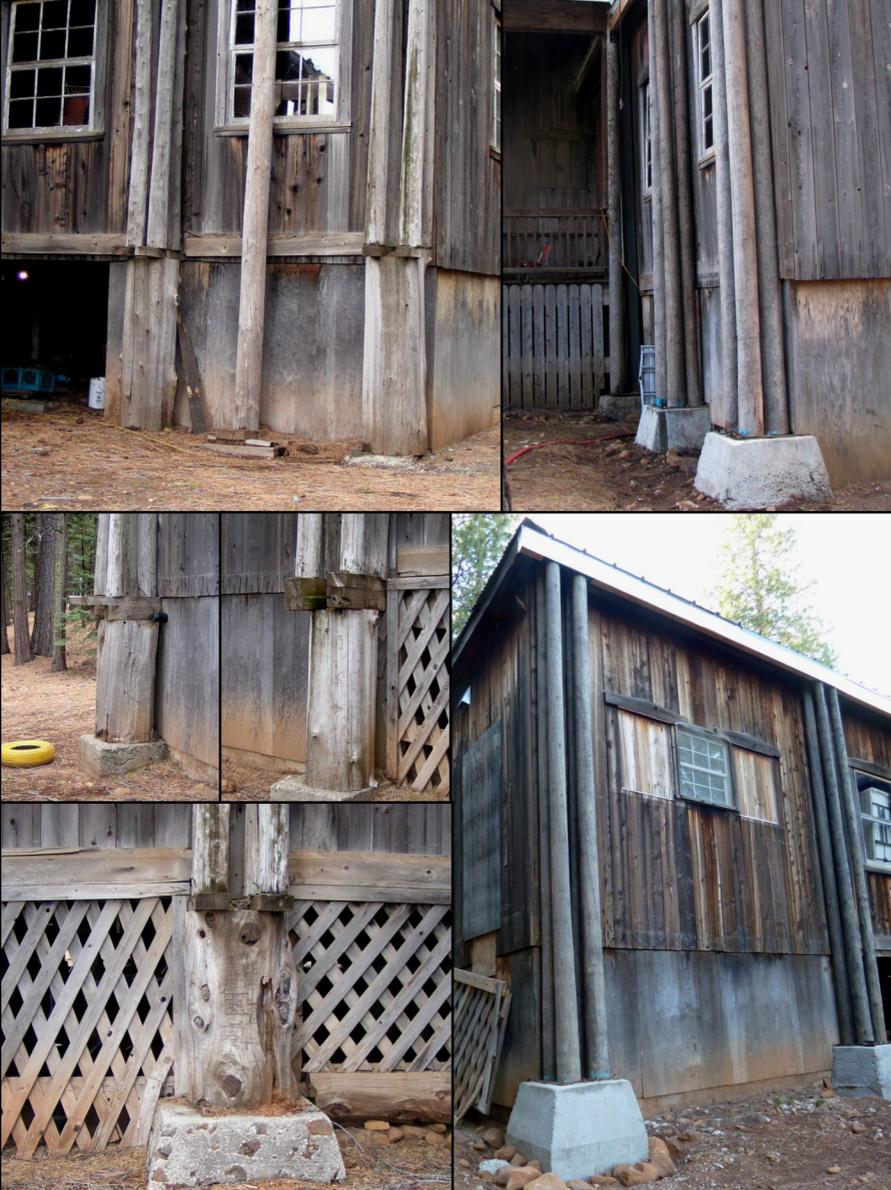
As it turns out, having a back up plan for an early winter turned out to be a good thing, as we began to receive a lot of indication of a cold wet and early winter. The decision was made not to wait for the late November weekends to finish up, but rather move forward with an early November middle of the week project. As its turns out, we had a sprinkling of snow on the last of October as a warning of things to come, and by November 13th the poles were in place and we were ready for winter.

Special Thanks is due to Uriah and John Bakke, Travis Vodden and Andrew Rohrer for getting the poles in place by November 12th. All they needed was 2 days to knock this out, but a week later, the early winter of 2010 & 2011 hit and we could not get back into camp for work projects till the spring. These contractors did a great job of finishing up, but they were so focused, they did not take any pictures of the progress. Typical of most Scout projects, the lasting testament of their labor, will be the finished project.
